Case Report

Reendodontic retreatment with apical radicular perforation of tooth 11: academic scientific case report.

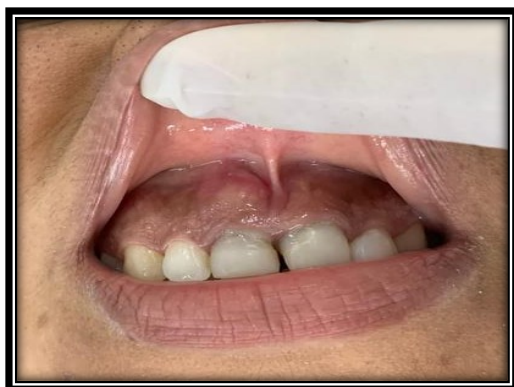
Patient MFBN, a 42-year-old female with melanoderma, sought treatment at the dental clinic of a Dentistry college located in the Ceará, reporting a history of trauma to tooth 11 with previous endodontic intervention. The intraoral clinical examination revealed darkening of the tooth, accompanied by edema and exudation (Figure 1). Subsequent periapical radiographic assessment revealed periapical radiolucency suggestive of root perforation in the apical region (Figure 2). To confirm the diagnosis of apical root perforation, a tomographic examination was performed.

Figure 1 - Initial clinical examination
Source: Own work.

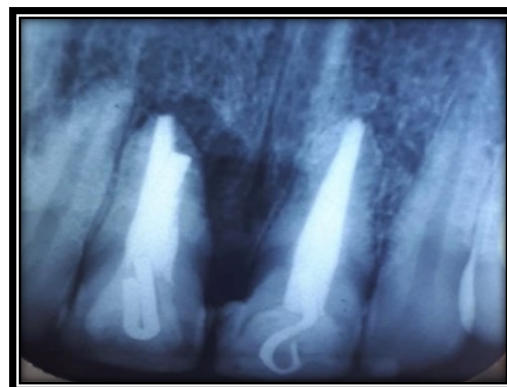
Figure 2 - Initial periapical radiograph
Source: Own work.

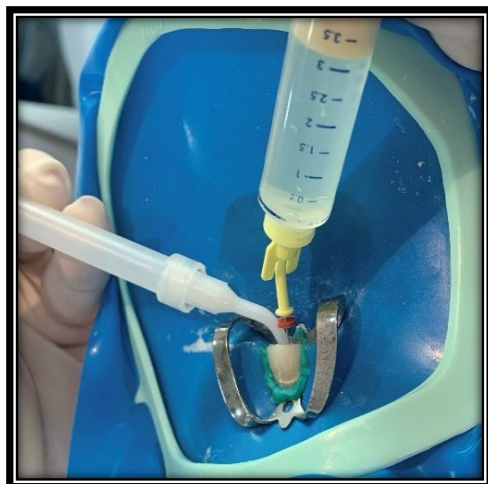
Figure 3 - Irrigation with 2.5% sodium hypochlorite
Source: Own work.

During the first treatment session, an infiltrative anesthesia of the anterior alveolar nerve was administered using 2% lidocaine with 1:100,000 epinephrine (DLF, Rio de Janeiro, Brazil) in tooth 11. Under rubber dam isolation, the clip employed as a fixed prosthesis retainer was removed using a diamond tip 1014 (KG-Sorensen, São Paulo, Brazil). The root canal was subsequently cleaned using a Reciproc R25 file and Clear Sonic ultrasonic insert (HELSE), aided by an electronic microscope, and abundant irrigation with 2.5% sodium hypochlorite (Figure 3).

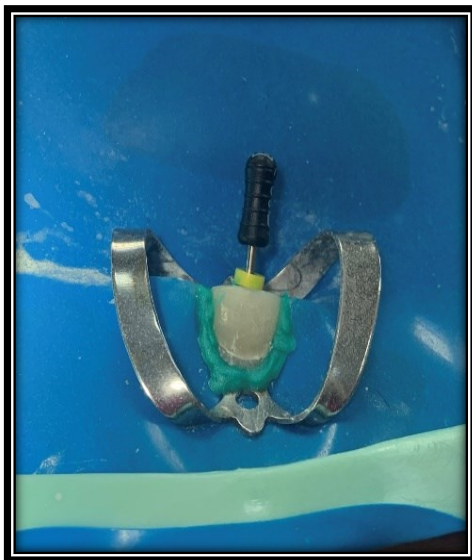
Figure 4 - 80 file to confirm CRT Source: Own work.

An 80 file was utilized to radiographically determine the working length (CRT) and perform root canal instrumentation (Figures 4 and 5). After biomechanical preparation, Bio-C Repair repair cement was carefully inserted at the site of the perforation using an absorbent paper point (Figure 6). Subsequently, the canal was filled with Calen plus PMCC, and a temporary restoration was applied. A follow-up periapical radiograph was taken to confirm the precise positioning of the repair cement within the perforation (Figure 7).

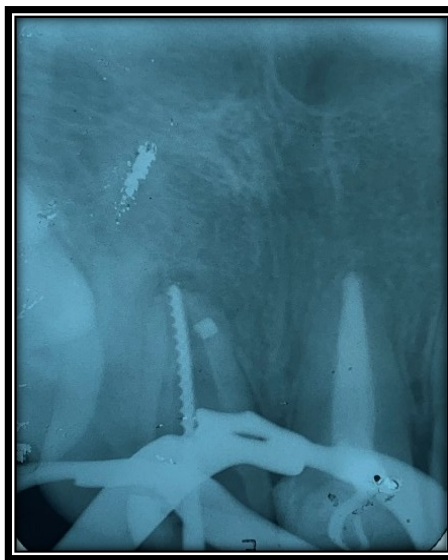
Figure 5 - Radiograph of 80 file to confirm CRT Source: Own work.

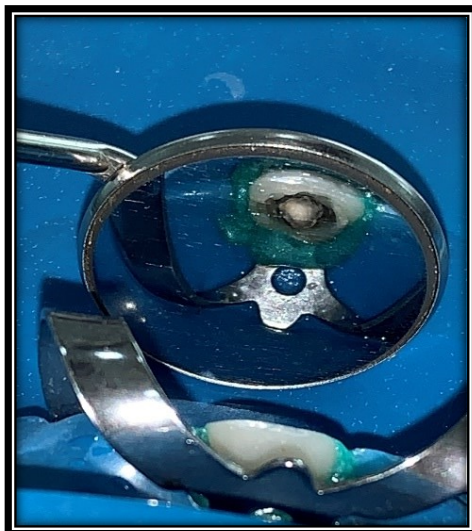
Figure 6 - Bioceramic cement sealing the perforation Source: Own work.

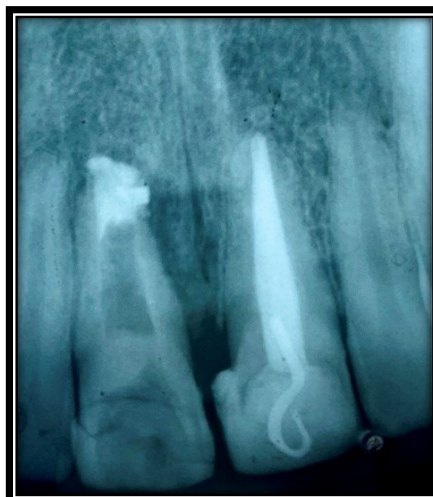
Figure 7 - Radiograph to evaluate the placement of Bio-C Repair cement Source: Own work.

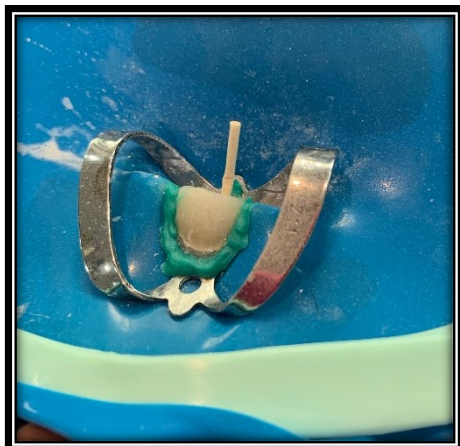
Figure 8 - Drying of the canal with an absorbent paper cone Source: Own work.

In the second treatment session, intracanal medication was removed using 2.5% sodium hypochlorite through Passive Ultrasonic Irrigation (PUI). Subsequent irrigation was carried out with EDTA and sodium hypochlorite, adhering to the final irrigation protocol. The canal was meticulously dried using capillary tips and absorbent paper cones (Figure 8). AH Plus sealer was employed for canal filling, and the warm vertical compaction technique was applied with the aid of McSpadden in low rotation (Figures 9 and 10). Finally, a radiograph was taken to verify the quality of the root canal filling (Figure 11).

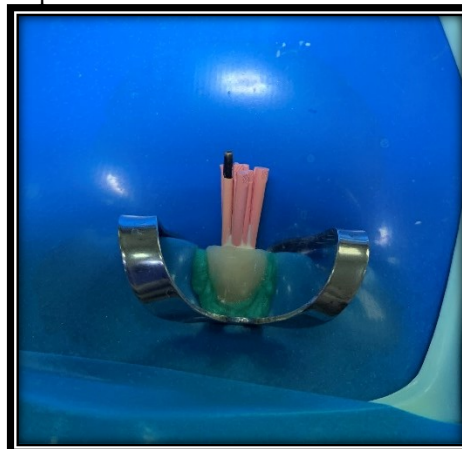
Figure 9 - Root canal filling with gutta-percha Source: Own work.

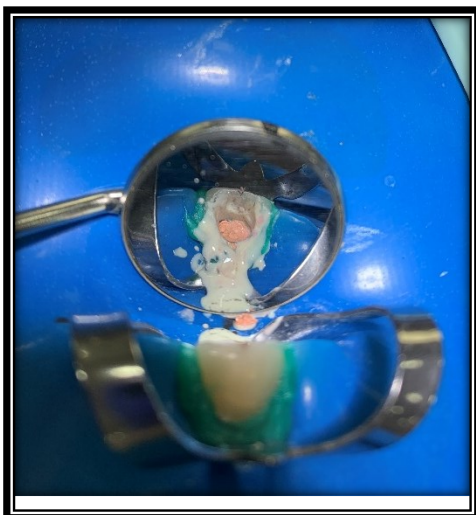
Figure 10 - Thermoplasticized gutta-percha Source: Own work.

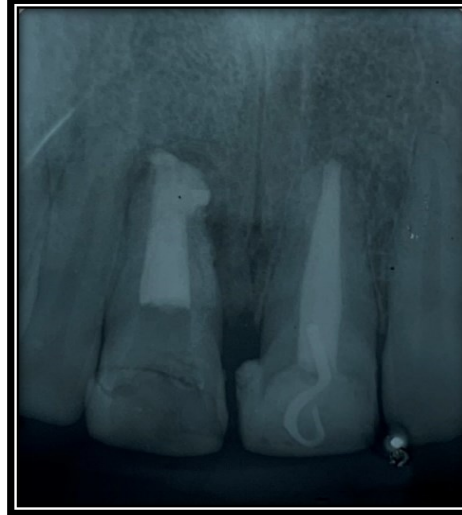
Figure 11 - Final periapical radiograph Source: Own work.
